Artifacts Practice 2017

Artifacts Practice 2017 Answer Section

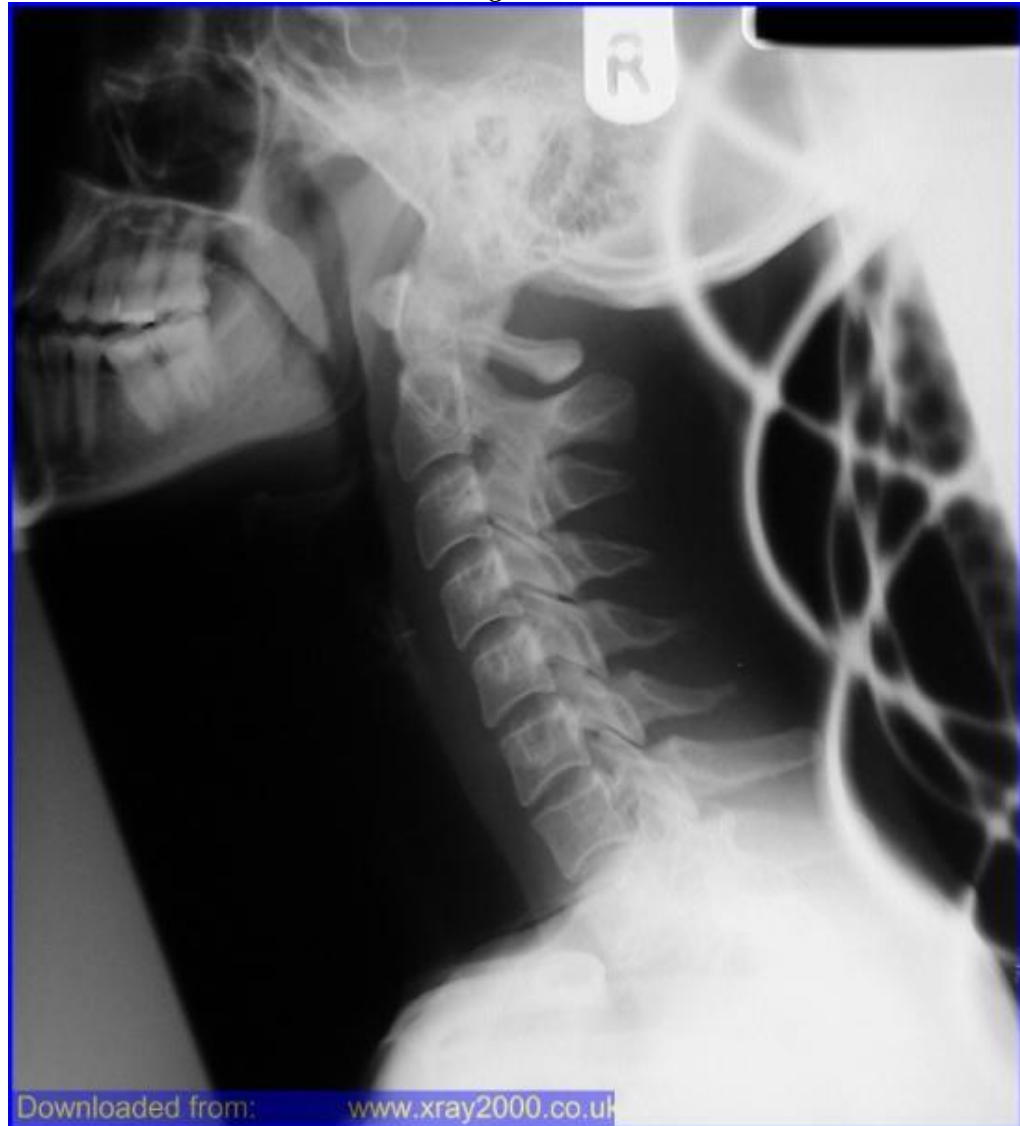
Figure 7

The high brightness semicircular radiographic artifacts seen in this lateral cervical radiograph were caused by:

- a. Mattress springs
- b. High voltage cables
- c. Cassette strips
- d. grid lead strips

1. ANS: B PTS: 1
2. ANS: D PTS: 1
3. ANS: C PTS: 1
4. ANS: B PTS: 1
5. ANS: E PTS: 1
6. ANS: E PTS: 1
7. ANS: D PTS: 1
8. ANS: B PTS: 1

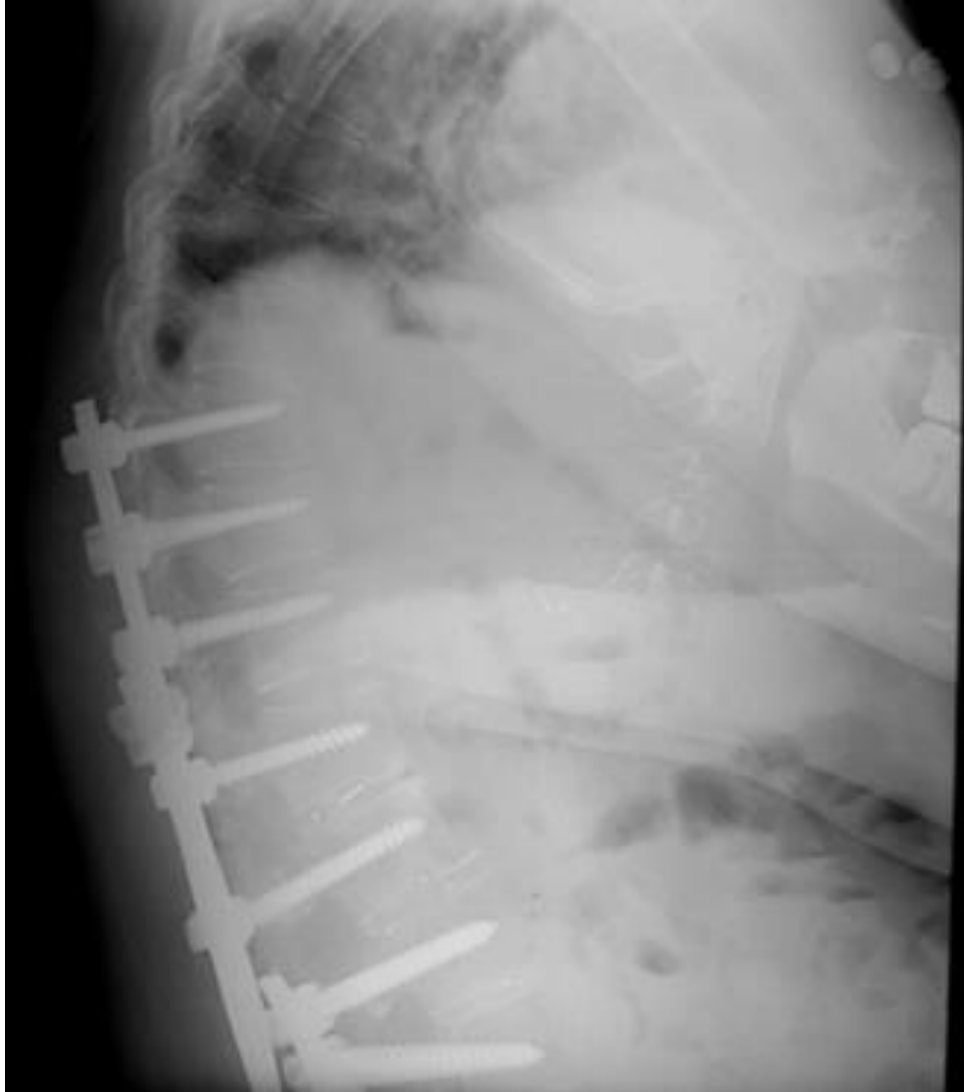
Figure 4

What was the most likely cause that necessitated a repeat of this thoraco-lumbar radiograph?

- a. IR placed upside down
- b. excessive scatter radiation
- c. An excessive timer setting resulting in the motion of the abdominal structures
- d. double exposure
- e. grid error

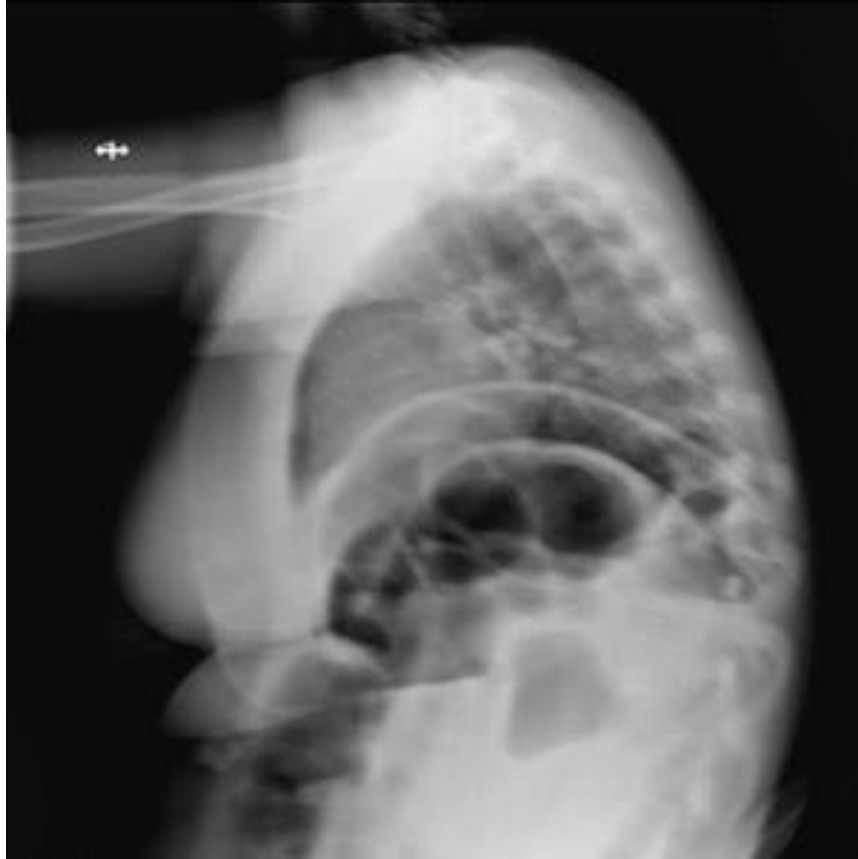
Figure 2

What was the most likely cause that necessitated a repeat of this chest radiograph?

- a. IR placed upside down
- b. excessive scatter radiation
- c. An excessive timer setting resulting in the motion of the structures
- d. An improper mAs

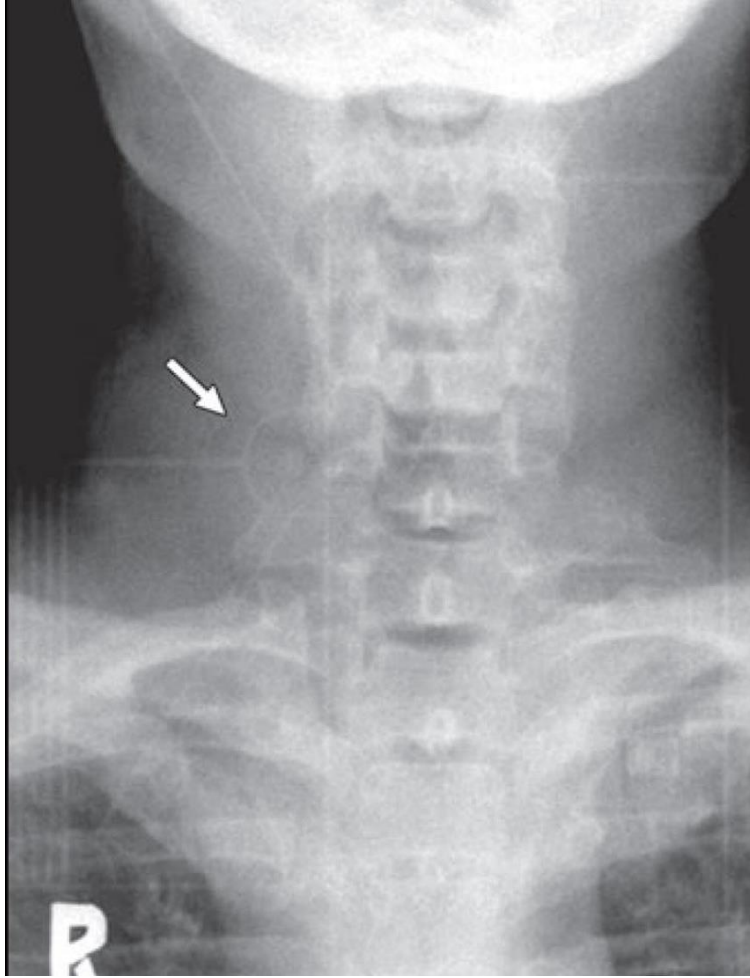
Figure 7

What was the most likely cause that necessitated a repeat of this C-spine radiograph?

- a. low kVp
- b. excessive scatter radiation
- c. An excessive timer setting
- d. double exposure
- e. grid error

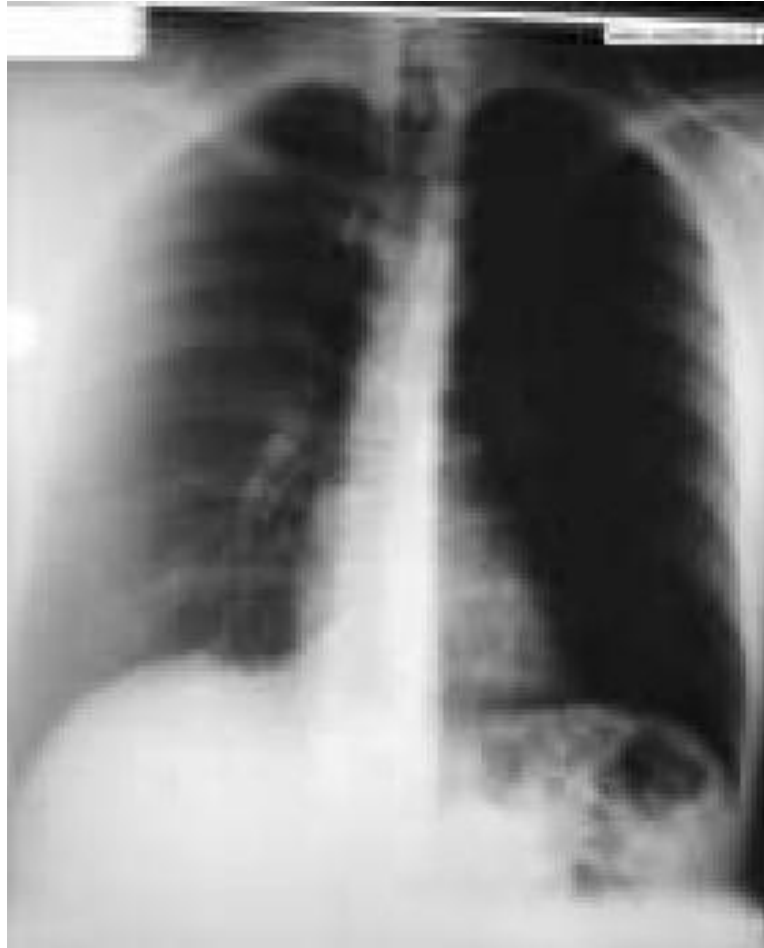
Figure 8

What was the most likely cause that necessitated a repeat of this radiograph?

- a. low kVp
- b. excessive scatter radiation
- c. An excessive timer setting
- d. double exposure
- e. grid error

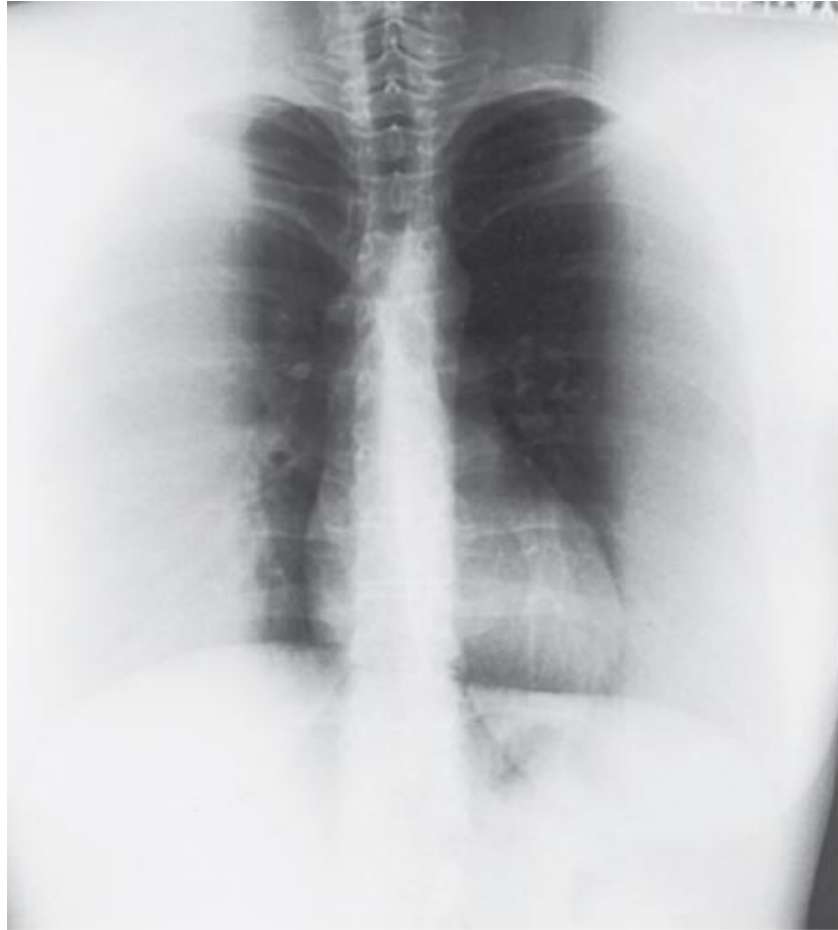
Figure 9

What was the most likely cause that necessitated a repeat of this radiograph?

- a. low kVp
- b. excessive scatter radiation
- c. An excessive timer setting
- d. double exposure
- e. grid error

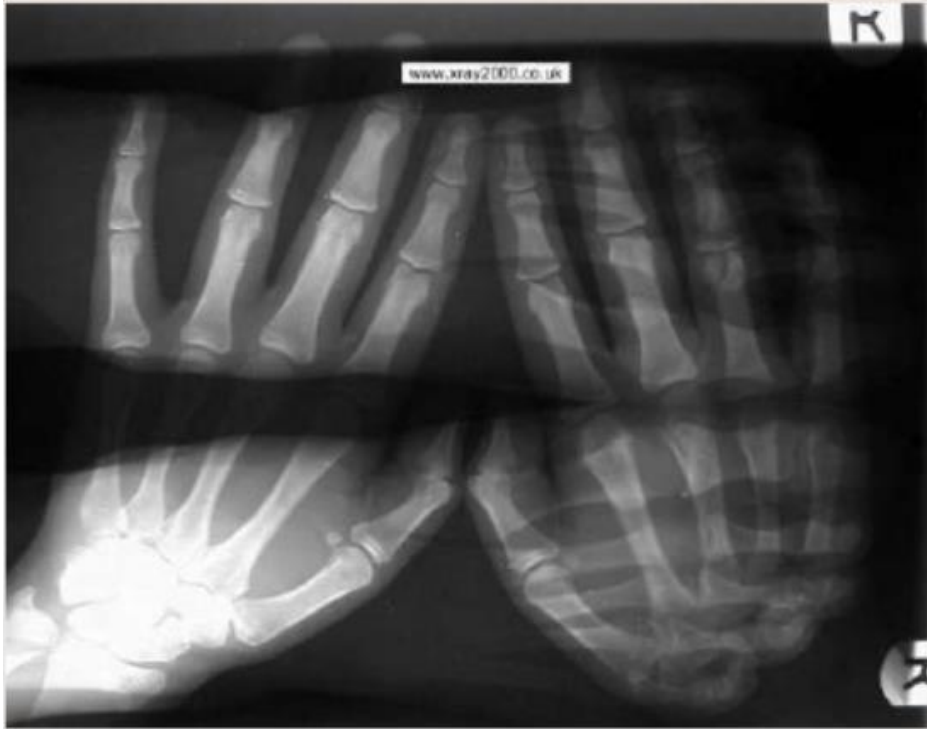
Figure 21

What was the most likely cause that necessitated a repeat of this radiograph?

- a. low kVp
- b. excessive scatter radiation
- c. An excessive timer setting
- d. double exposure
- e. grid error

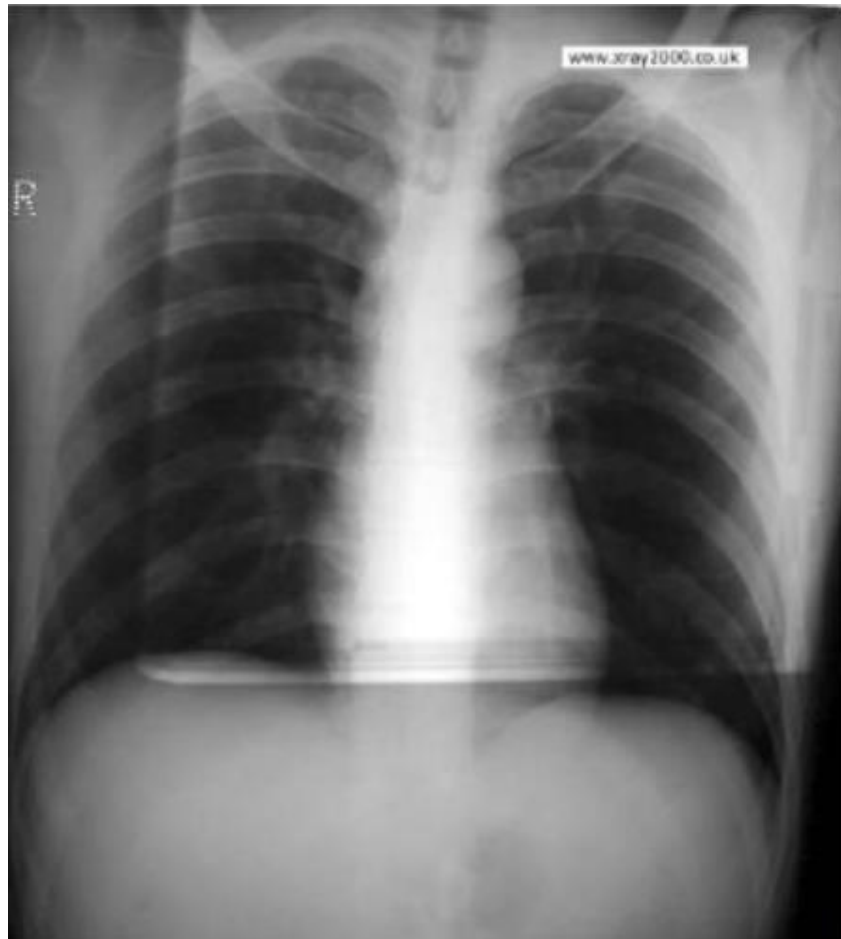
Figure 22

What was the most likely cause that necessitated a repeat of this chest radiograph?

- a. low kVp
- b. excessive scatter radiation
- c. An excessive timer setting
- d. double exposure
- e. grid error

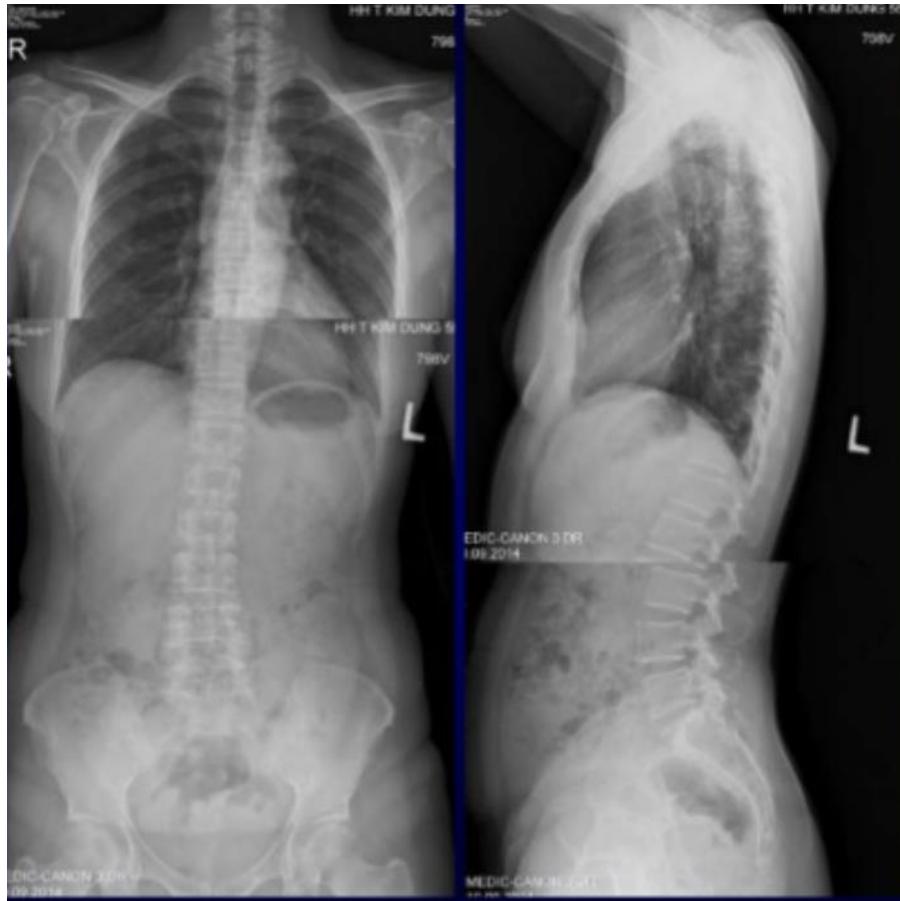
Figure 11
Artifact

The artifacts (staircase) illustrated in Figure 11 was caused by:

9. ANS:
Bad stitching

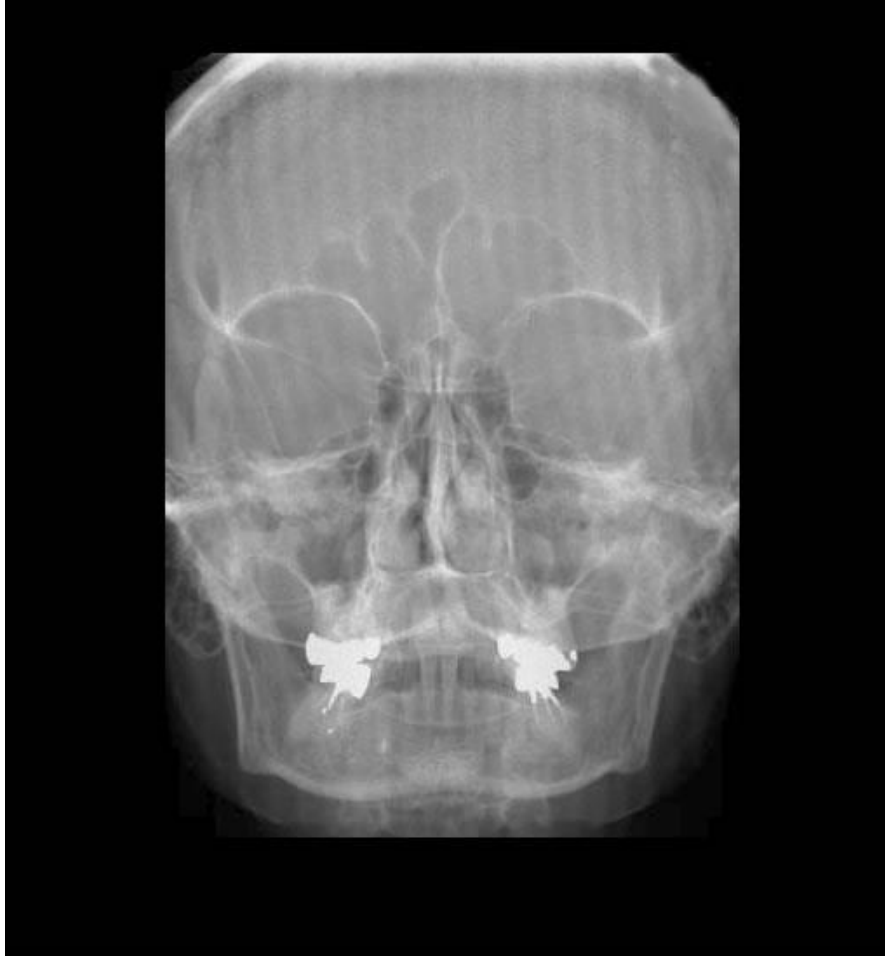
Figure 12
Artifact

The artifact illustrated in Figure 12 was caused by:

PTS: 1
10. ANS:
Moire artifact (low frequency grid)

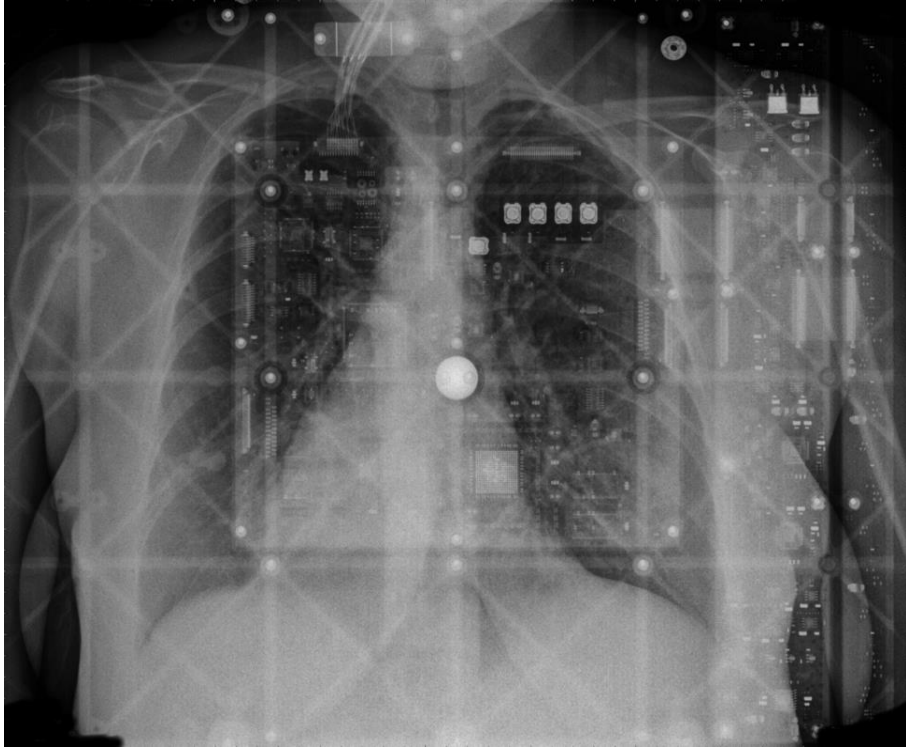
Figure 13
Artifact

The artifact illustrated in Figure 13 was caused by:

PTS: 1
11. ANS:
IR upside-down

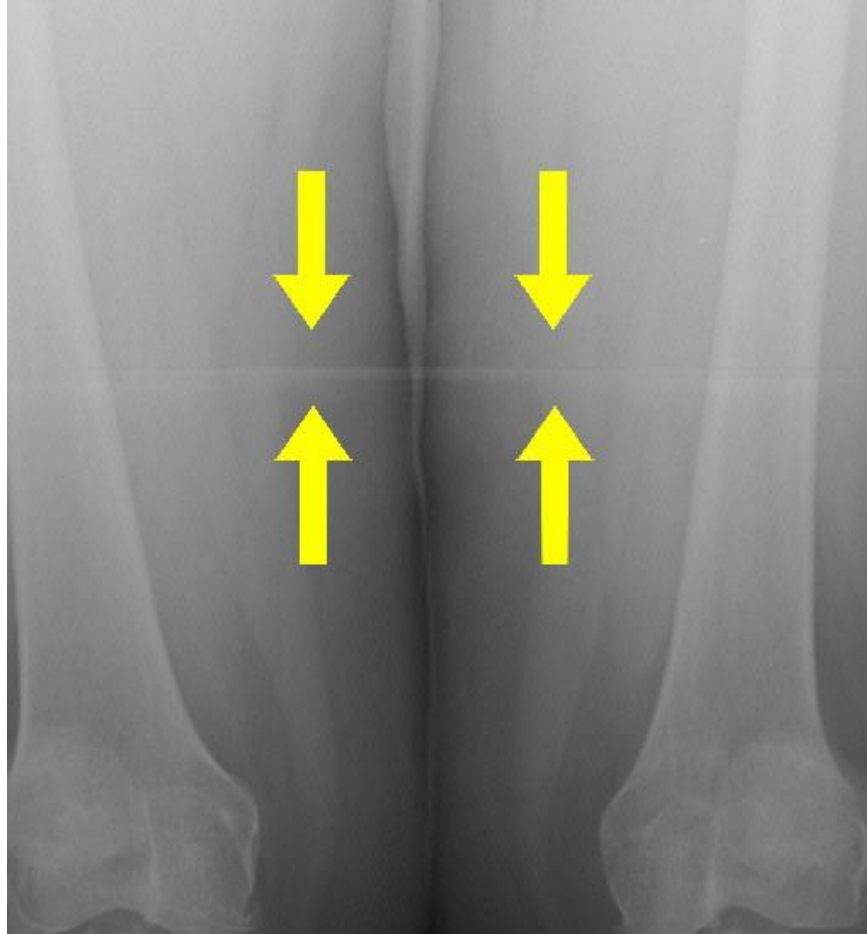
Figure 14
Artifact

The artifact illustrated in Figure 14 was caused by:

PTS: 1
12. ANS:
Bad stitching

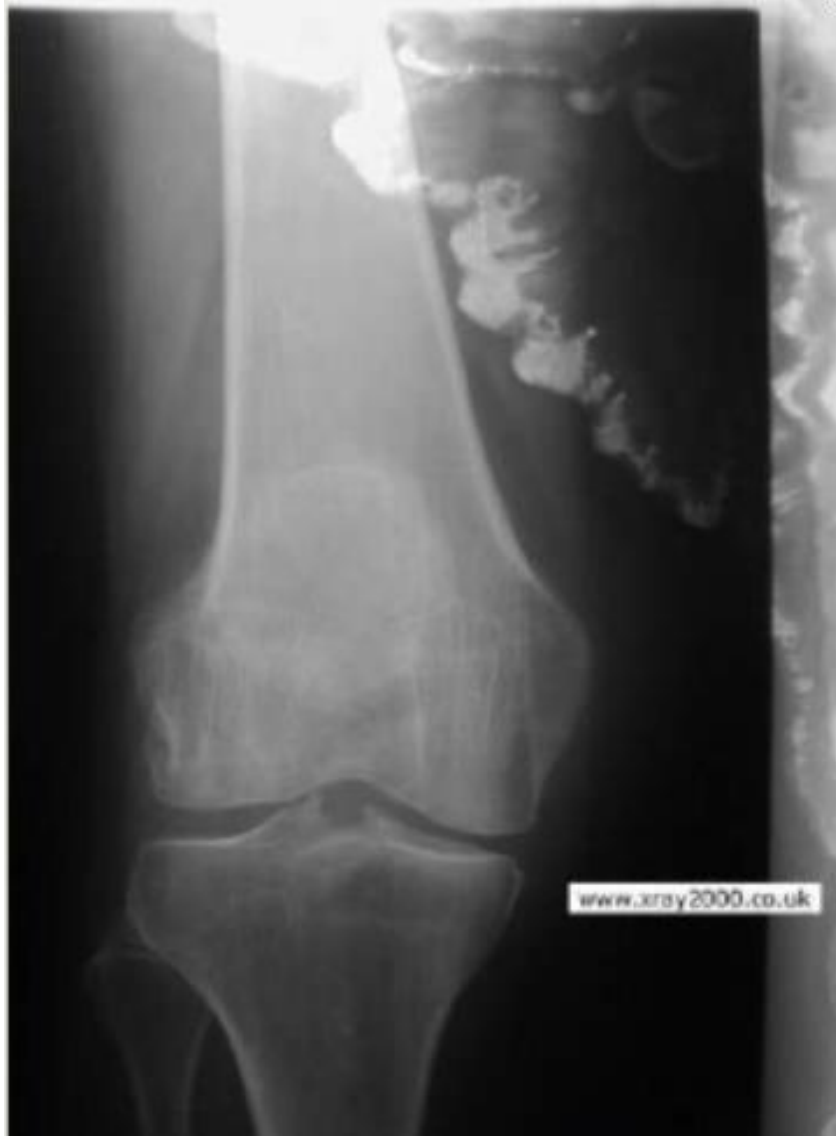
Figure 15
Artifact

The artifact illustrated in Figure 15 was caused by:

PTS: 1
13. ANS:
Contrast medium spill

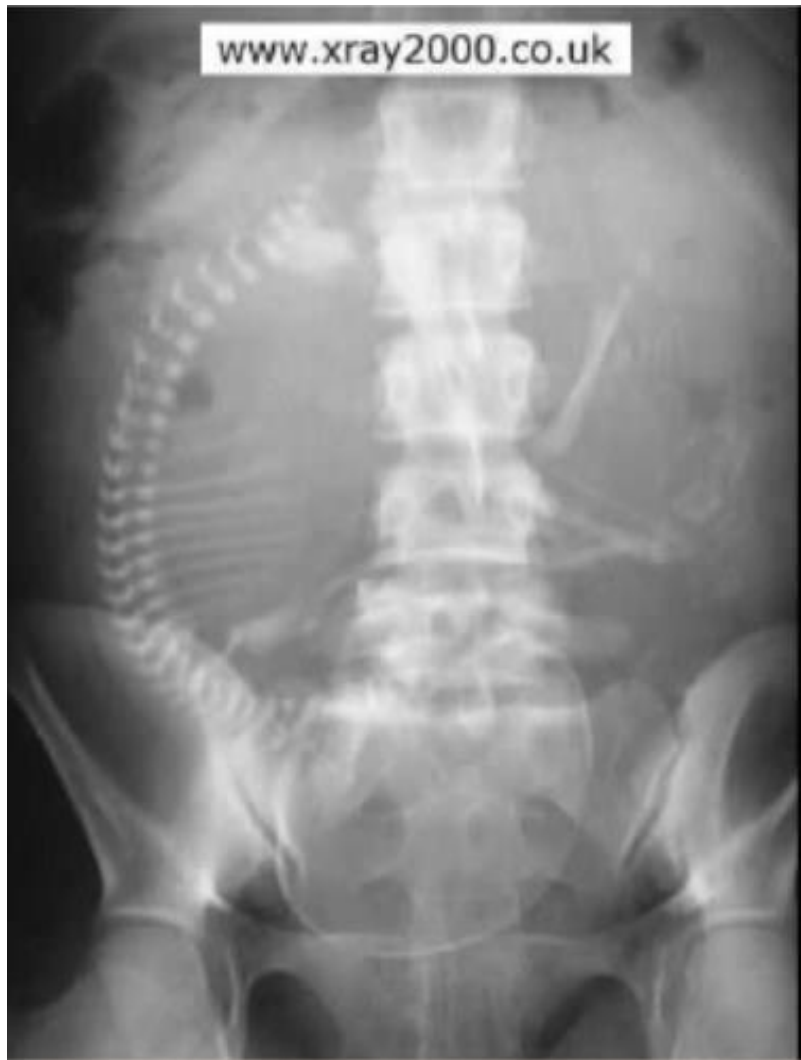
Figure 16
Artifact

The artifact illustrated in Figure 16 was caused by:

PTS: 1
14. ANS:
Baby?

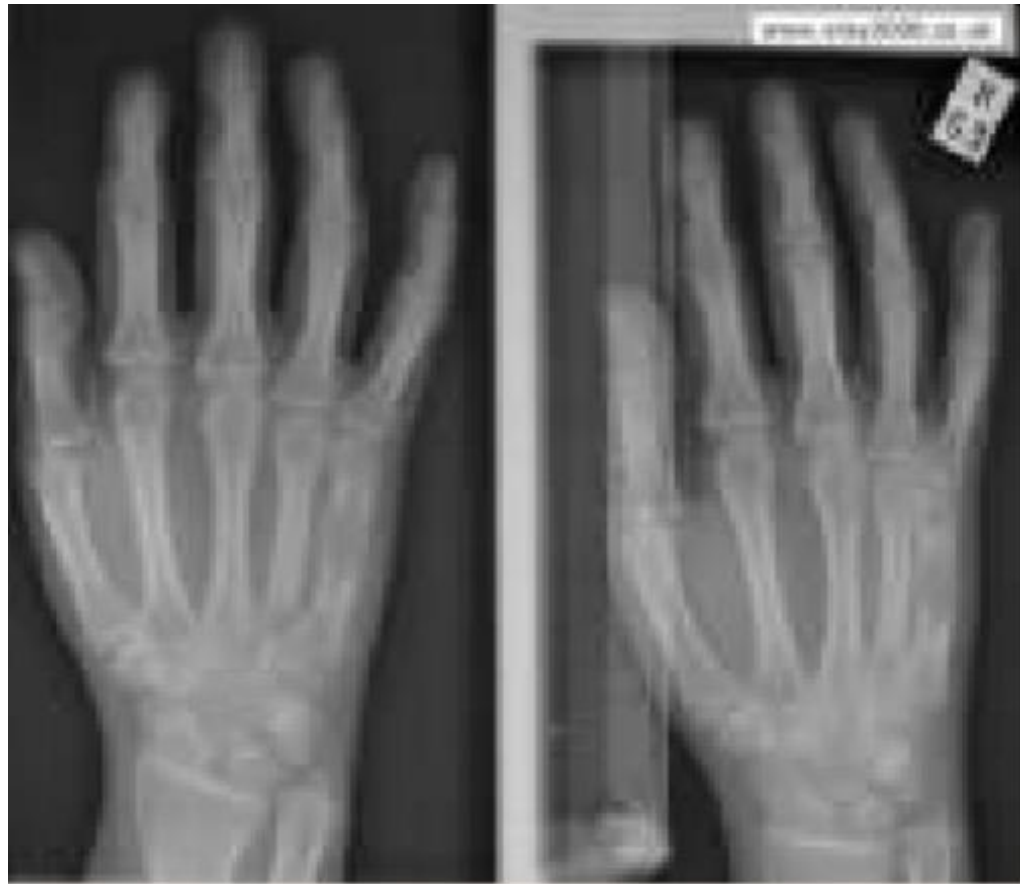
Figure 17
Artifact

The artifact illustrated in Figure 17 was caused by:

PTS: 1
15. ANS:
Sand Bag
